Applies To: 2016 Civic Model Series – ALL

November 2015

2016 Civic: New Model Body Repair Information

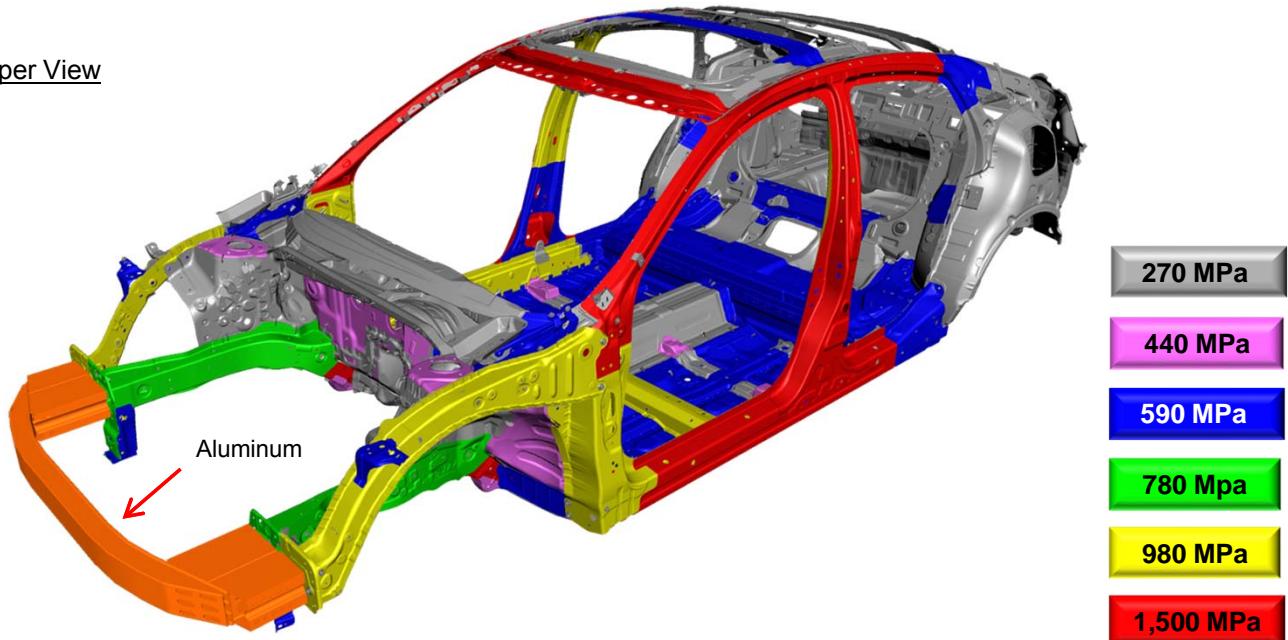
Upper View

- Steel parts are color coded based on their tensile strength in megapascals (MPa).
- High-strength steel (HSS) is defined as any steel with a tensile strength of 340 MPa or higher.
- Ultra-high-strength steel (UHSS) is defined as any steel with a tensile strength of 980 MPa or higher.
- Steel repair and welding procedures vary depending on the tensile strength of the parts involved.

These illustrations are for general reference only. Some body parts are constructed from multiple layers of different tensile strength steels. Refer to the body service information's body construction section for specific steel tensile strength information.

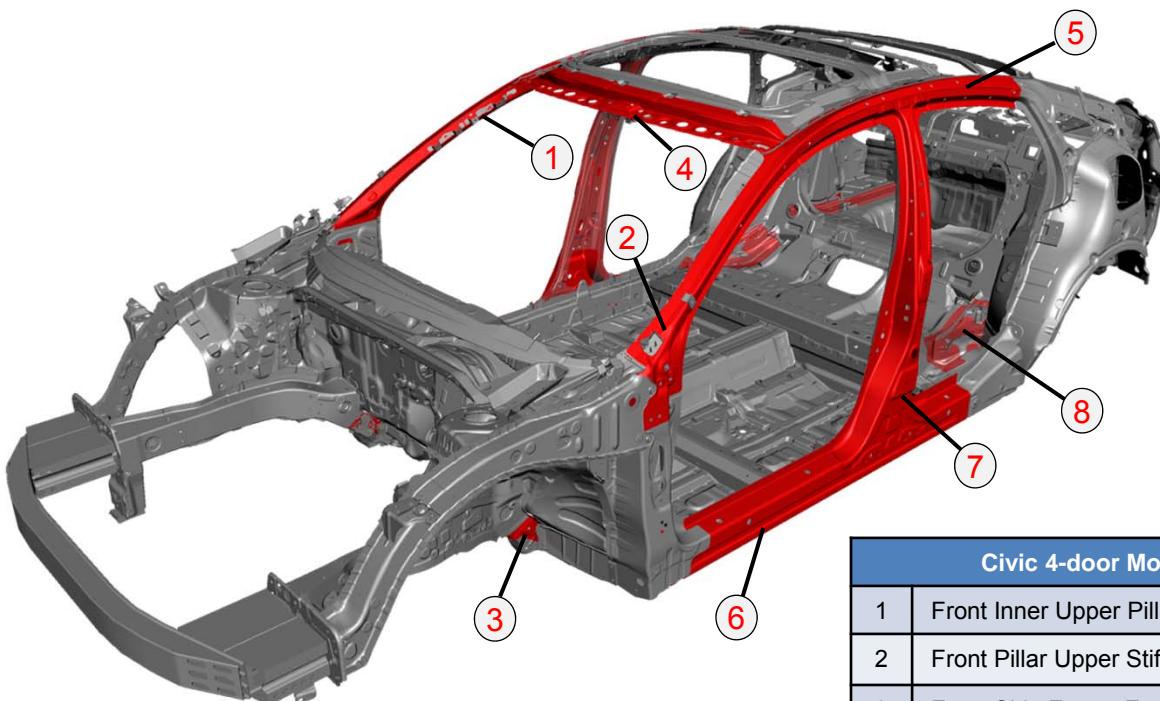
The numbered parts in the diagram below are constructed of 1,500 MPa steel:

Civic 4-door Models	
1	Front Inner Upper Pillar
2	Front Pillar Upper Stiffener
3	Front Side Frame Extension
4	Roof Front Rail
5	Roof Side Stiffener
6	Side Sill Reinforcement
7	Center Pillar Stiffener
8	Rear Frame

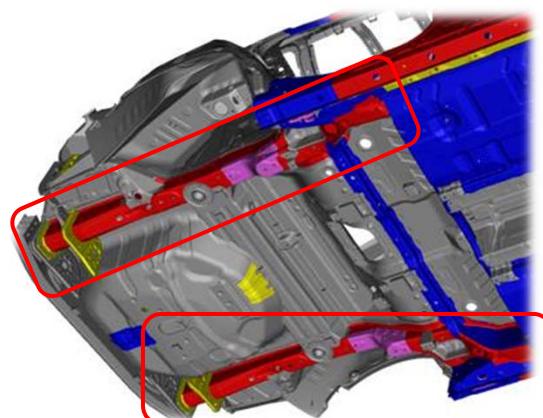
4-door models utilize weight-saving 1,500 MPa steel rear frame rails with soft zones for impact crush control.

- If rear frame damage is suspected, measure the **entire** vehicle using a three-dimensional measuring system.
- If the rear frame is damaged, replace the affected rear frame(s) as a complete assembly only.
- The traditional replacement of only the rear portion of the frame (Rear Frame B) is **not** possible because the 1,500 MPa rear frame **cannot be sectioned**.
- For further repair information, refer to the following:
 - “Repairing 1,500 MPa Steel Parts” on **page 7** of this publication.
 - “Rear Floor/Rear Frame Replacement” in the body service information.

1,500 MPa Steel Rear Frame Rails

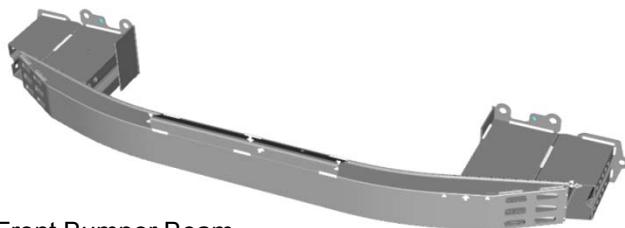
The front bumper beam uses 6000 series aluminum alloy construction.

- Do not repair damaged bumper beams.
- To help prevent galvanic corrosion, some fasteners for aluminum parts are considered one-time use and must be replaced if removed.

Front Bumper Beam

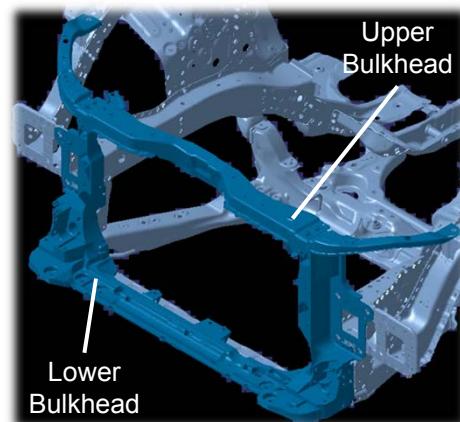
This vehicle has a lower bulkhead assembly constructed of resin composite material.

- The upper bulkhead frame is constructed of 270 MPa mild steel.
- The front upper and lower bulkheads are only sold as a complete assembly.
- The bulkhead design improves engine compartment access during factory assembly and service.
- The cooling fans, radiator, A/C condenser, hood lock, outside air temperature sensor, and related piping/components are attached to the front bulkhead.
- The bulkhead is attached to the body with 20 bolts.
- A damaged bulkhead must be replaced.
- For more information, refer to "Front Bulkhead Replacement" in the body service information.

Resin Composite Front Bulkhead

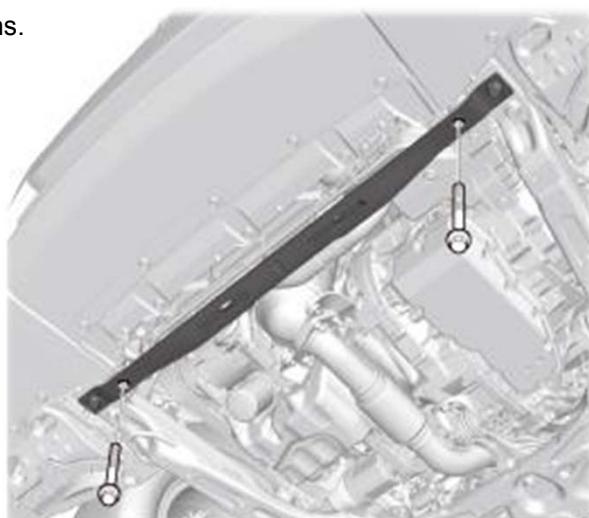
This front brace is located under the front bumper directly ahead of the front subframe.

- The front brace is attached to the body using special collar bolts that compensate for body dimensional variations.
- A special removal and installation procedure is required
- For more information, refer to "Front Brace Removal and Installation" in the service information.

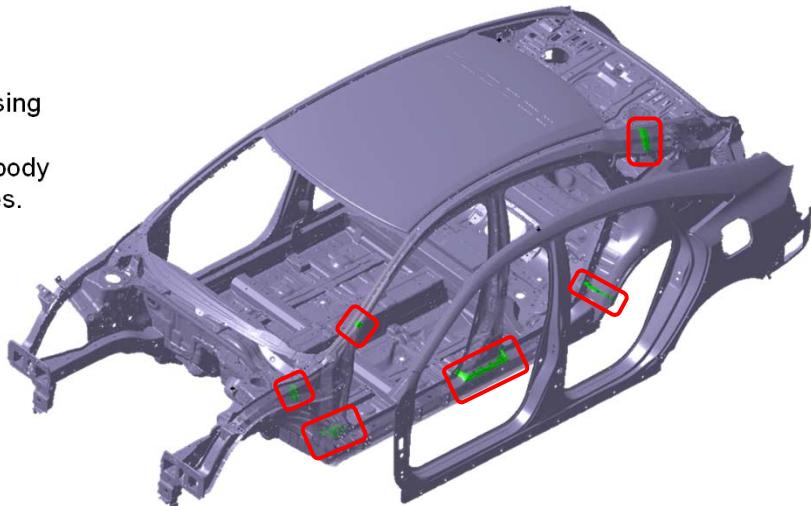
A combination of molded, extruded, and tape acoustic separators are applied in various body locations.

- Locations are shown in the diagram below.
- These are applied within the body pillars.
- They are designed to block noise paths into the cabin from hollow body cavities.
- Repairs are similar to previous models using commercially-available products.
- Refer to the Replacement section of the body service information for specific procedures.

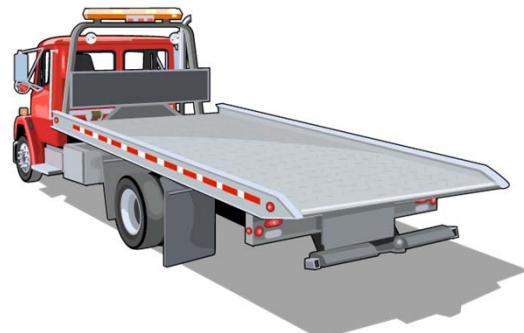
- Lift or jack only at the specified points to avoid damaging the vehicle.
- **Do not** lift or tow this vehicle by its bumpers, or serious damage will result.

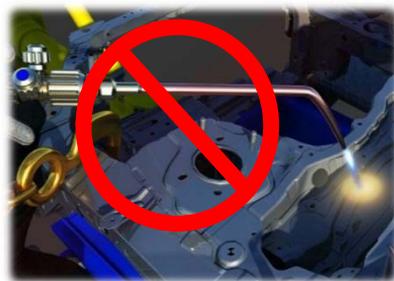
- **Do not** apply heat to any body part during straightening. This may compromise the internal structure and strength of high-strength steel parts.
- Any part that has heat applied to it during straightening **must** be replaced with new parts.
- Ignoring these instructions may significantly reduce occupant protection in any subsequent collision.

Do not heat during straightening

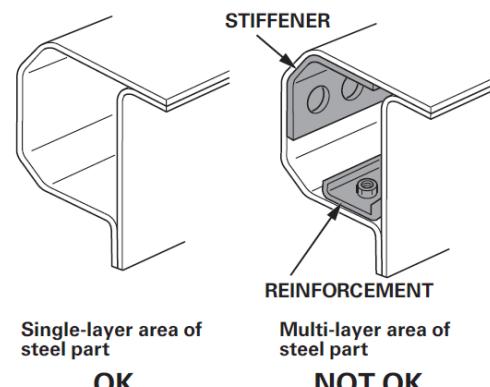
- Sectioning (cut and joint) should usually be avoided except for mild steel outer panels and floor panels unless a specific procedure is provided in the body service information.
- However, depending on the type of vehicle damage, steel parts with a tensile strength ≤ 780 MPa may be sectioned provided **all** of the following conditions are met:
 - Sectioning must be done in a single-layer area of the part.
 - Multi-layer internal steel reinforcements and stiffeners must not be cut.
 - The repair is not in a load-bearing area such as engine, transmission, or suspension mounting points.
- Replace body structural components such as stiffeners, reinforcements, and other multi-layered steel parts as assemblies that match the replacement parts configuration.
- Approved welding methods are listed in the table on the right.
- Refer to the body service information for complete information.

Sectioning Area Examples

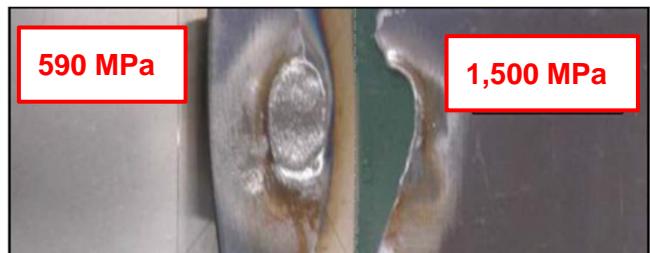
- **Never** do MAG welding on 1,500 MPa steel. The heat generated during MAG welding will significantly reduce the strength and structural integrity of 1,500 MPa steel parts.
- The photo on the right shows tensile strength test results of MAG welded 1,500 MPa steel. The 1,500 MPa steel fractured first because the welding heat reduced its strength to far below 590 MPa.
- For more details, refer to the body service information "Basic Welding Information" section.

Tensile Test Results of MAG-Welded 1,500 MPa Steel

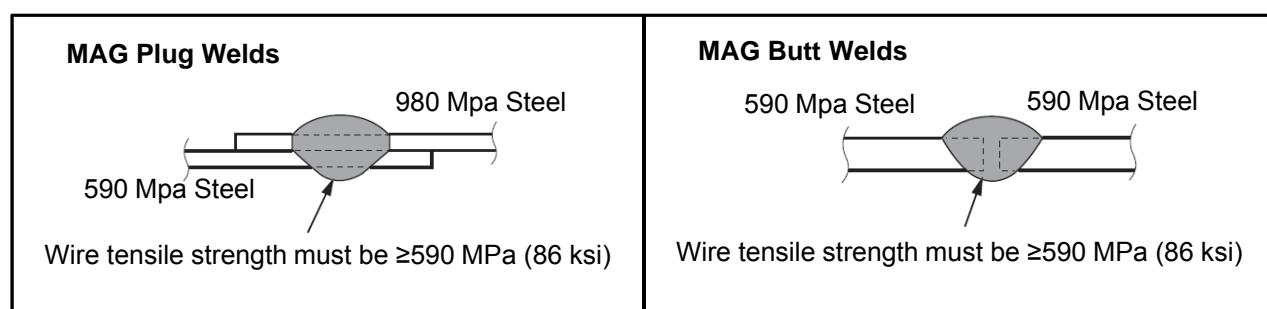
- The welding wire used must have a tensile strength equal to or greater than the lowest tensile strength of the parts being welded. The conversion chart on the right shows the relationship of steel tensile strength (MPa) to the minimum welding wire tensile strength (ksi).
- Typical ER70S-6 MIG wire has a minimum tensile strength of 70 ksi (483 MPa). It can be used when welding up to 440 MPa steel parts. Refer to the diagrams shown below:

Steel Tensile (MPa)	Wire Tensile (ksi)
590	≥86
780	≥113
980	≥142

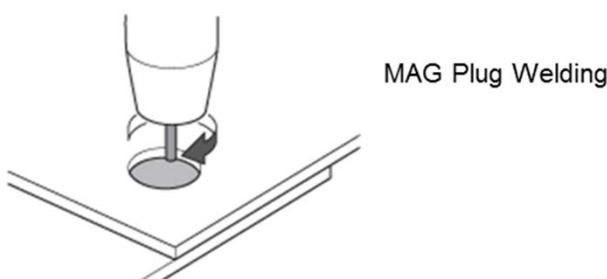
- MAG plug welding may be done when joining body components to 590–980 MPa steel parts.
- Follow the recommendations described in the body service information “Basic Welding Information” section.

MAG Plug Welding

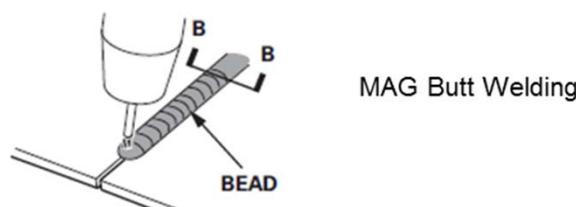
- MAG butt welding may be done **only** on steel parts with a tensile strength of 780 MPa and lower.
- Welding speed is critical to achieve the correct weld strength and minimize the heat affected zone (HAZ).
- Follow the recommendations described in the body service information “Basic Welding Information” section.

MAG Butt Welding

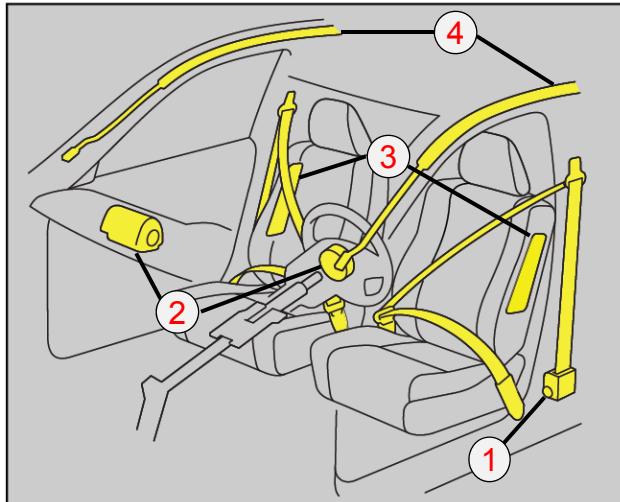
1. Driver's and front passenger's seat belt tensioners (may deploy independently from any airbags).
2. Driver's and front passenger's SRS airbags.
3. Side airbags mounted in the driver's and front passenger's outer seat-backs.
4. Side curtain airbags mounted above the left and right side windows under the headliner.

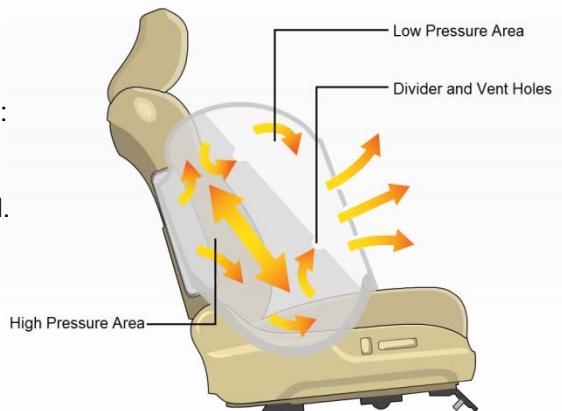
- This airbag design helps mitigate the risk of excessive airbag deployment force and risk of injury to smaller seat occupants.
- It eliminates the need for the occupant position detection system (OPDS) sensor located in the front passenger's seat-back.

- Special seat covers and/or breakaway thread are used to ensure the proper deployment path.
- Damaged front seat covers should be replaced, not repaired.
- Do not install non-factory seat covers; they may alter the airbag's intended deployment path.

SmartVent Side Airbag

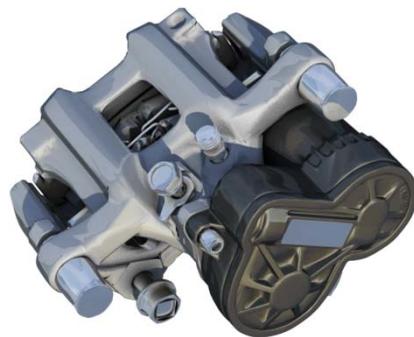
- Electric actuators on each rear brake caliper apply and release the brake pads.
- A manual procedure is provided if a malfunction prevents parking brake release.
- Refer to "Electric Parking Brake Forced Cancellation," in the service information.

Electric Parking Brake Caliper

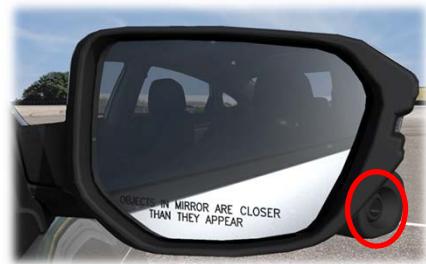
LaneWatch is an assistance system that uses a camera in the passenger's side door mirror along with the center display. It helps provide improved visibility of passenger side rear area for the driver.

LaneWatch Camera Location

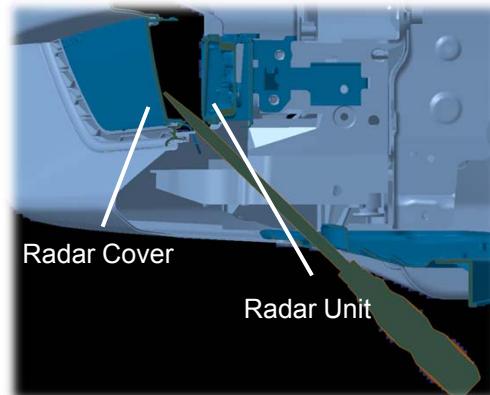
Some models are equipped with Adaptive Cruise Control and a Collision Mitigation Braking System™ (CMBS™). These systems use a millimeter wave radar unit mounted behind a plastic cover on the lower left side of the front bumper.

- This radar unit senses through a plastic cover attached to the left front fog light trim using hook-style clips.
- This part is specially designed to prevent radar interference.
- Do not paint or install any coverings over the radar cover. This may cause the Collision mitigation braking system indicator to come on and DTC P2583-97 (dust or dirt on the millimeter wave radar) to set.
- Radar cover removal requires a specific procedure and can be difficult. Refer to "Millimeter Wave Radar - Vertical Radar Aim" in the service information.

Side Cutaway View - Left Front Bumper Area

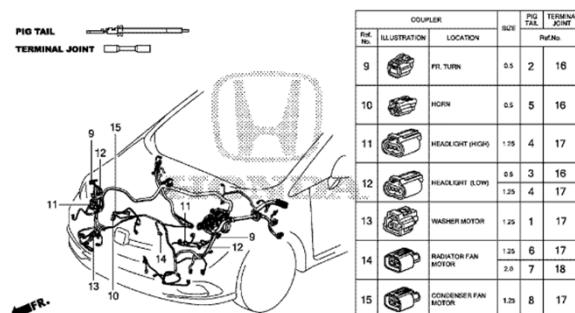
- Certain front and rear electrical connectors subject to collision damage may be repaired using pigtailed and connectors listed in the ELECTRICAL CONNECTORS illustrations in the parts catalog (example shown here).

- Pigtails attach to the vehicle wiring using special crimp-and-seal terminal joints. After crimping, the joints are heated using a heat gun to seal out the environment.

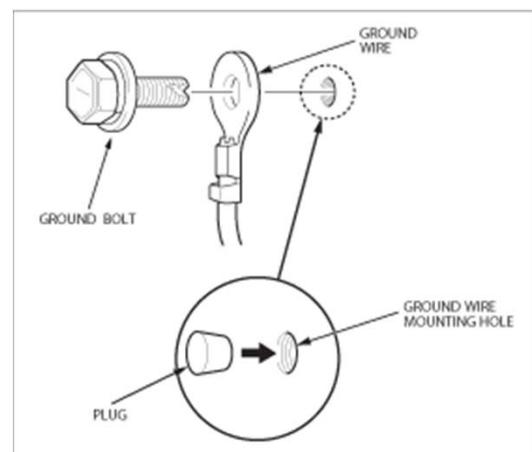
Failure to protect ground locations is the #1 cause of post-collision electrical problems on our vehicles.

- Painting over electrical ground locations may cause electrical systems, such as vehicle stability assist (VSA), to malfunction and set DTCs that may be difficult to diagnose.
- Protect the ground wire with masking tape and the ground wire mounting hole threads with a bolt or silicone plug when priming or painting.
- Honda ground bolts are almost always non-anodized, zinc plated self-cutting bolts. They can be identified by the triangular notch in the threads. Using the wrong bolt can cause ground problems.
- Do not use star or burred washers on electrical grounds.
